**Flood Control Project Maintenance
Levee Inspections**

Fall 2011 Levee Maintenance Deficiency Summary Report

Reclamation District No. 0785 Driver

Levee Inspection Report By Mile - Fall 2011

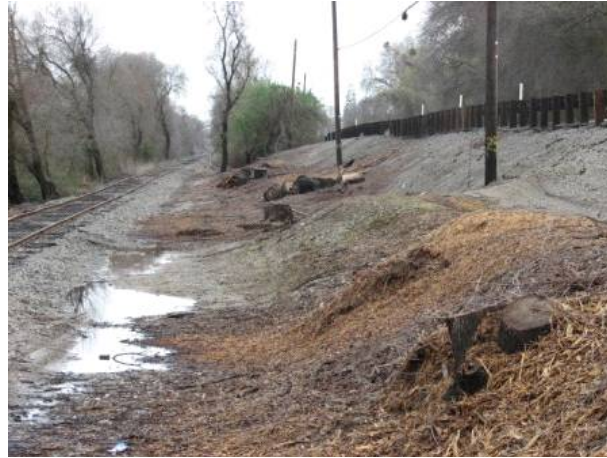
Levee Mile Report Line	1
Start Levee Mile	0.13
End Levee Mile	1.36
Location	Land Side
Category	Earthen Levee
Item	Trim / Thin Trees
The trees were cut by PG&E'S tree contractor. The district will take care of the stumps in the future.	
johngw_f_20110923_258.jpg

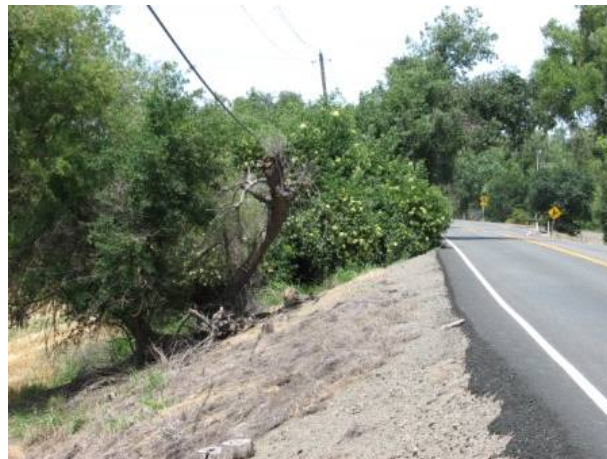
Levee Mile Report Line	2
Start Levee Mile	0.29
End Levee Mile	0.29
Location	Land Side
Category	Earthen Levee
Item	Vegetation
Elderberry	
johngw_f_20110923_256.jpg

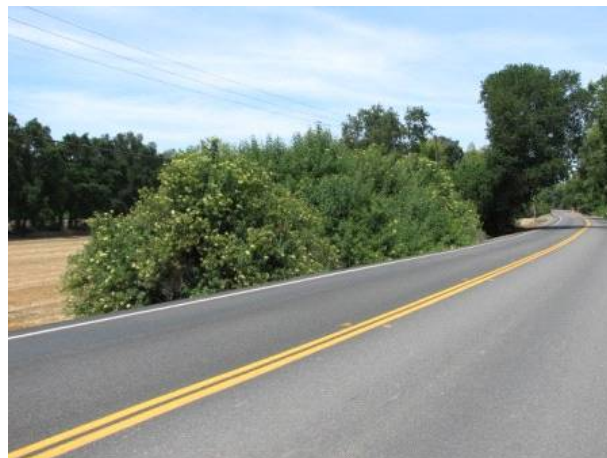
Levee Mile Report Line	3
Start Levee Mile	0.41
End Levee Mile	0.45
Location	Land Side
Category	Earthen Levee
Item	Vegetation
Elderberry	
johngw_f_20110923_257.jpg

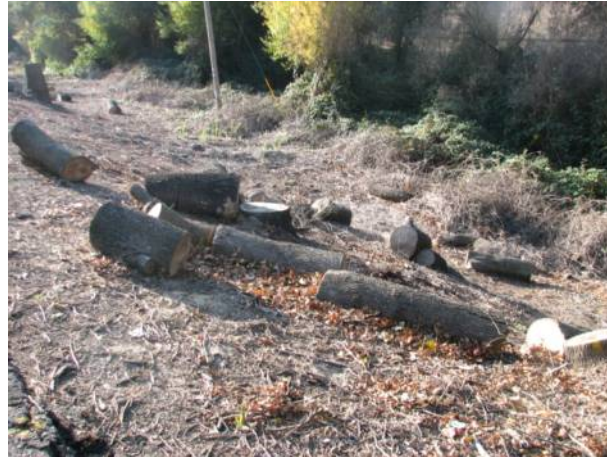
Levee Mile Report Line	4
Start Levee Mile	0.75
End Levee Mile	0.75
Location	Land Side
Category	Earthen Levee
Item	Encroachments
Wood is still on the levee slope from when trees where cut. Fall 2011	
johngw_f_20111116_559.jpg

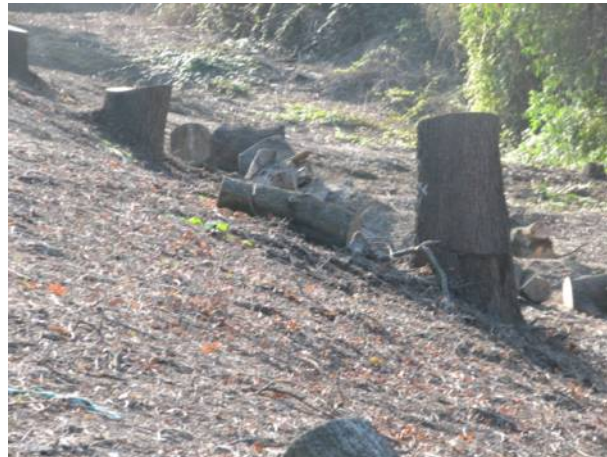
Levee Mile Report Line	4
Start Levee Mile	0.75
End Levee Mile	0.75
Location	Land Side
Category	Earthen Levee
Item	Encroachments
More wood still on levee slope. Fall 2011	
johngw_f_20111116_560.jpg

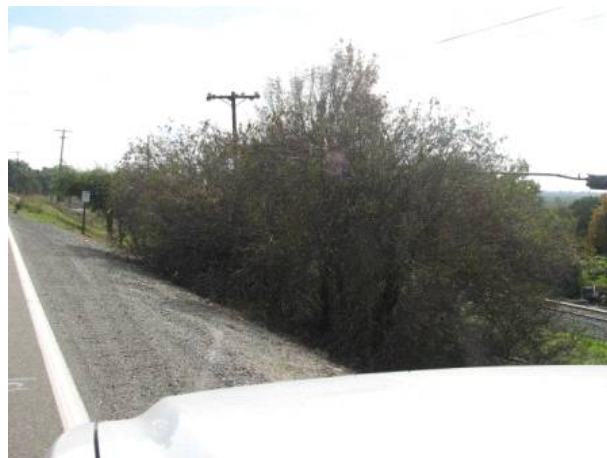
Levee Mile Report Line	6
Start Levee Mile	1.32
End Levee Mile	1.32
Location	Land Side
Category	Earthen Levee
Item	Vegetation
This is a very large Elderberry bush	
johngw_f_20110923_259.jpg

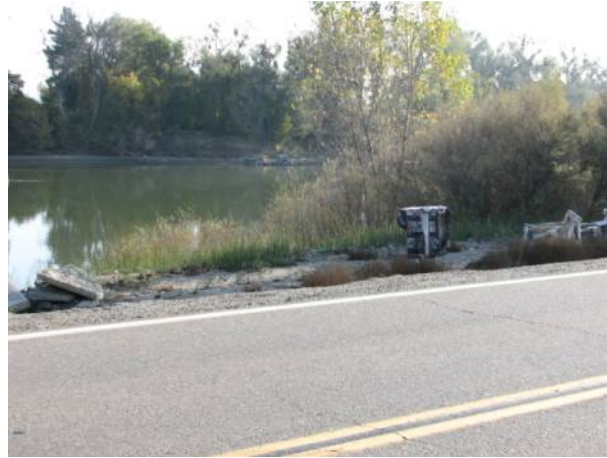
Levee Mile Report Line	7
Start Levee Mile	1.39
End Levee Mile	1.39
Location	Water Side
Category	Earthen Levee
Item	Encroachments

There is concrete debris and furniture that has been dropped off. Fall 2011

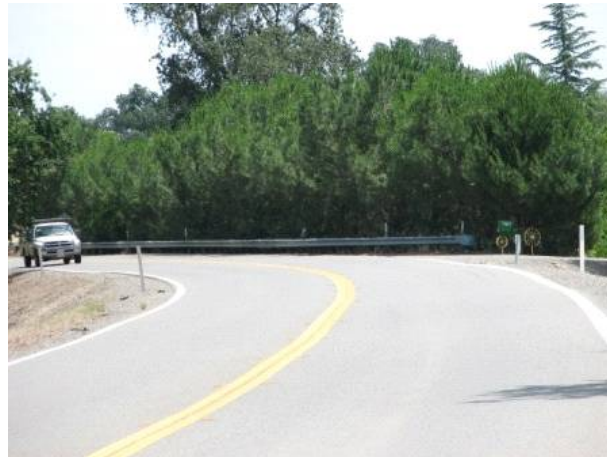
Levee Mile Report Line	8
Start Levee Mile	2.04
End Levee Mile	2.14
Location	Land Side
Category	Earthen Levee
Item	Encroachments

Pines and oleanders along shoulder.

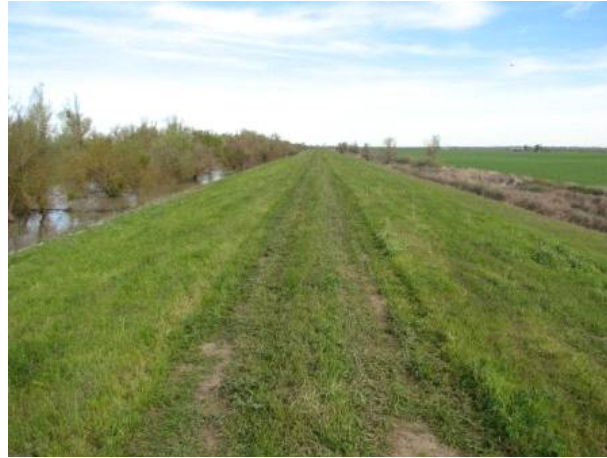
Levee Mile Report Line	3
Start Levee Mile	1.01
End Levee Mile	3.25
Location	Crown
Category	Earthen Levee
Item	Crown Surface / Depressions / Rutting

The vegetation on the crown needs to be sprayed and graded.

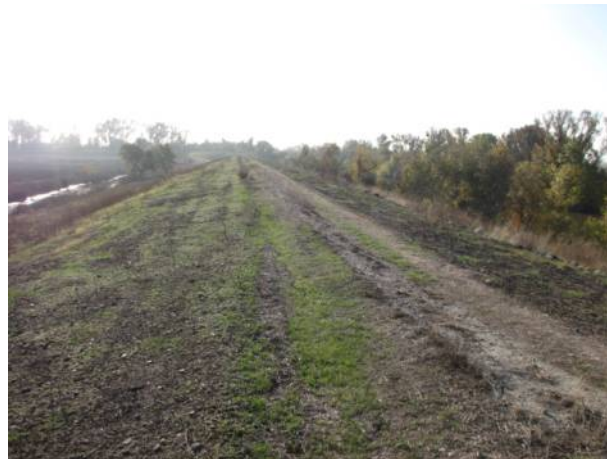
Levee Mile Report Line	3
Start Levee Mile	1.01
End Levee Mile	3.25
Location	Crown
Category	Earthen Levee
Item	Crown Surface / Depressions / Rutting

The vegetation on the crown has improved but needs to be sprayed. Fall 2011

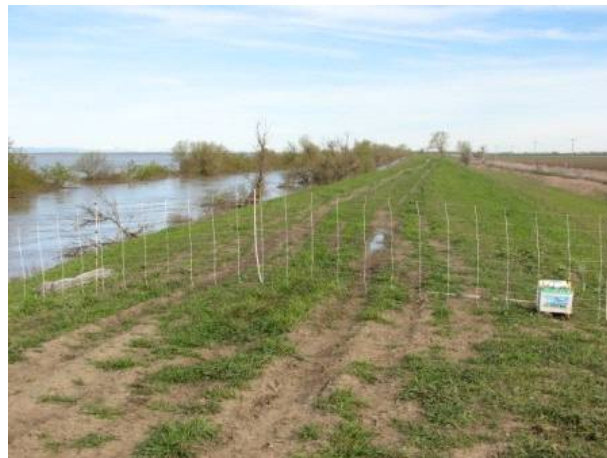
Levee Mile Report Line	4
Start Levee Mile	1.50
End Levee Mile	1.50
Location	Crown
Category	Earthen Levee
Item	Crown Surface / Depressions / Rutting

The crown of the levee with vegetation on the roadway. There is some depressions on the crown from vehicle use.

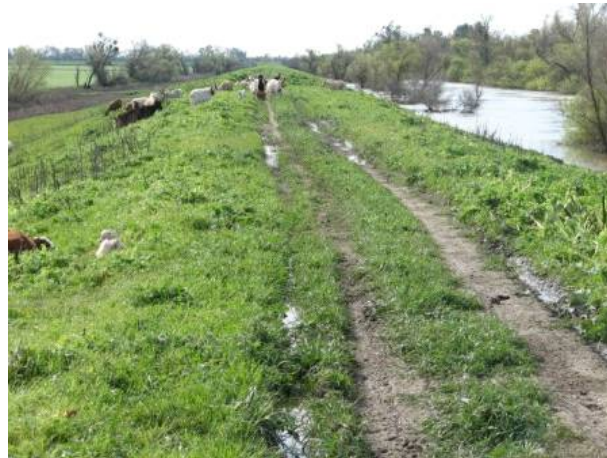
Levee Mile Report Line	5
Start Levee Mile	1.67
End Levee Mile	1.67
Location	Crown
Category	Earthen Levee
Item	Crown Surface / Depressions / Rutting
The crown needs to have gravel added to have an all weather surface.	
johngw_f_20110923_263.jpg
